**A GEOTECHNICAL REPORT  
(GFSH-2 PHASE 1)  
TO VALUMAX ON  
PTN 183 OLIFANTSFONTEIN 410 IR**

**IR1252**

**JULY 2014**

**A GEOTECHNICAL REPORT (GFSH – 2 PHASE 1) TO VALUMAX ON PORTION 183  
OLIFANTSFONTEIN 410 IR**

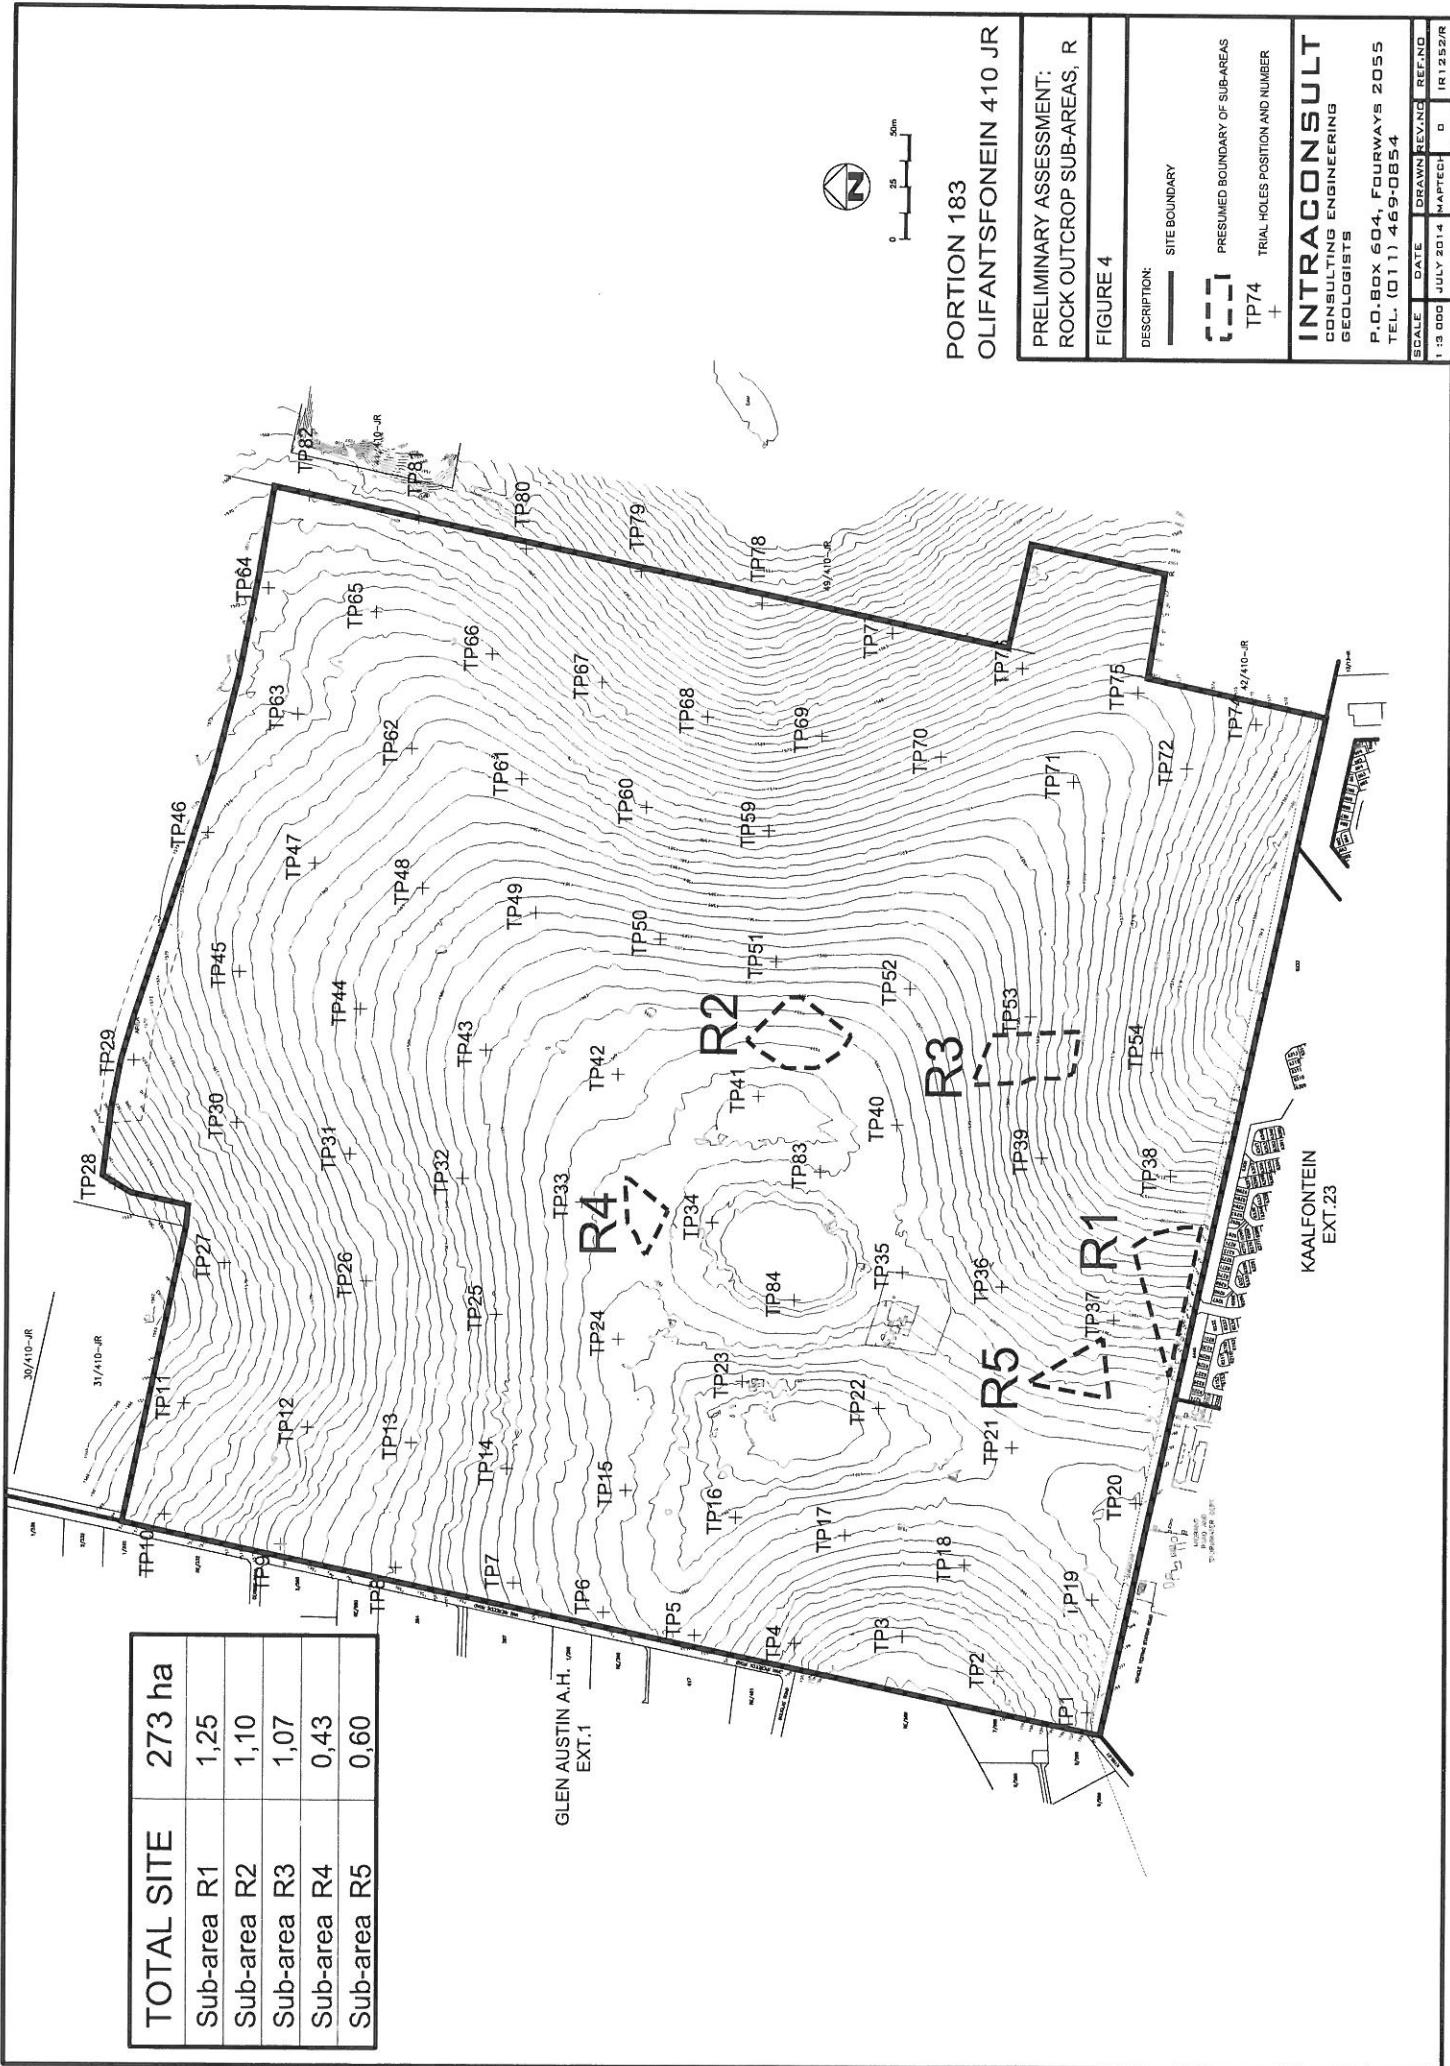
and hard rock (r1, r2, r4 and r5) were observed during this survey. It should be noted that other areas of rock outcrop could occur firstly below the waste area (shown on Figure 3) and secondly in other areas of the site currently covered by veld grasses.

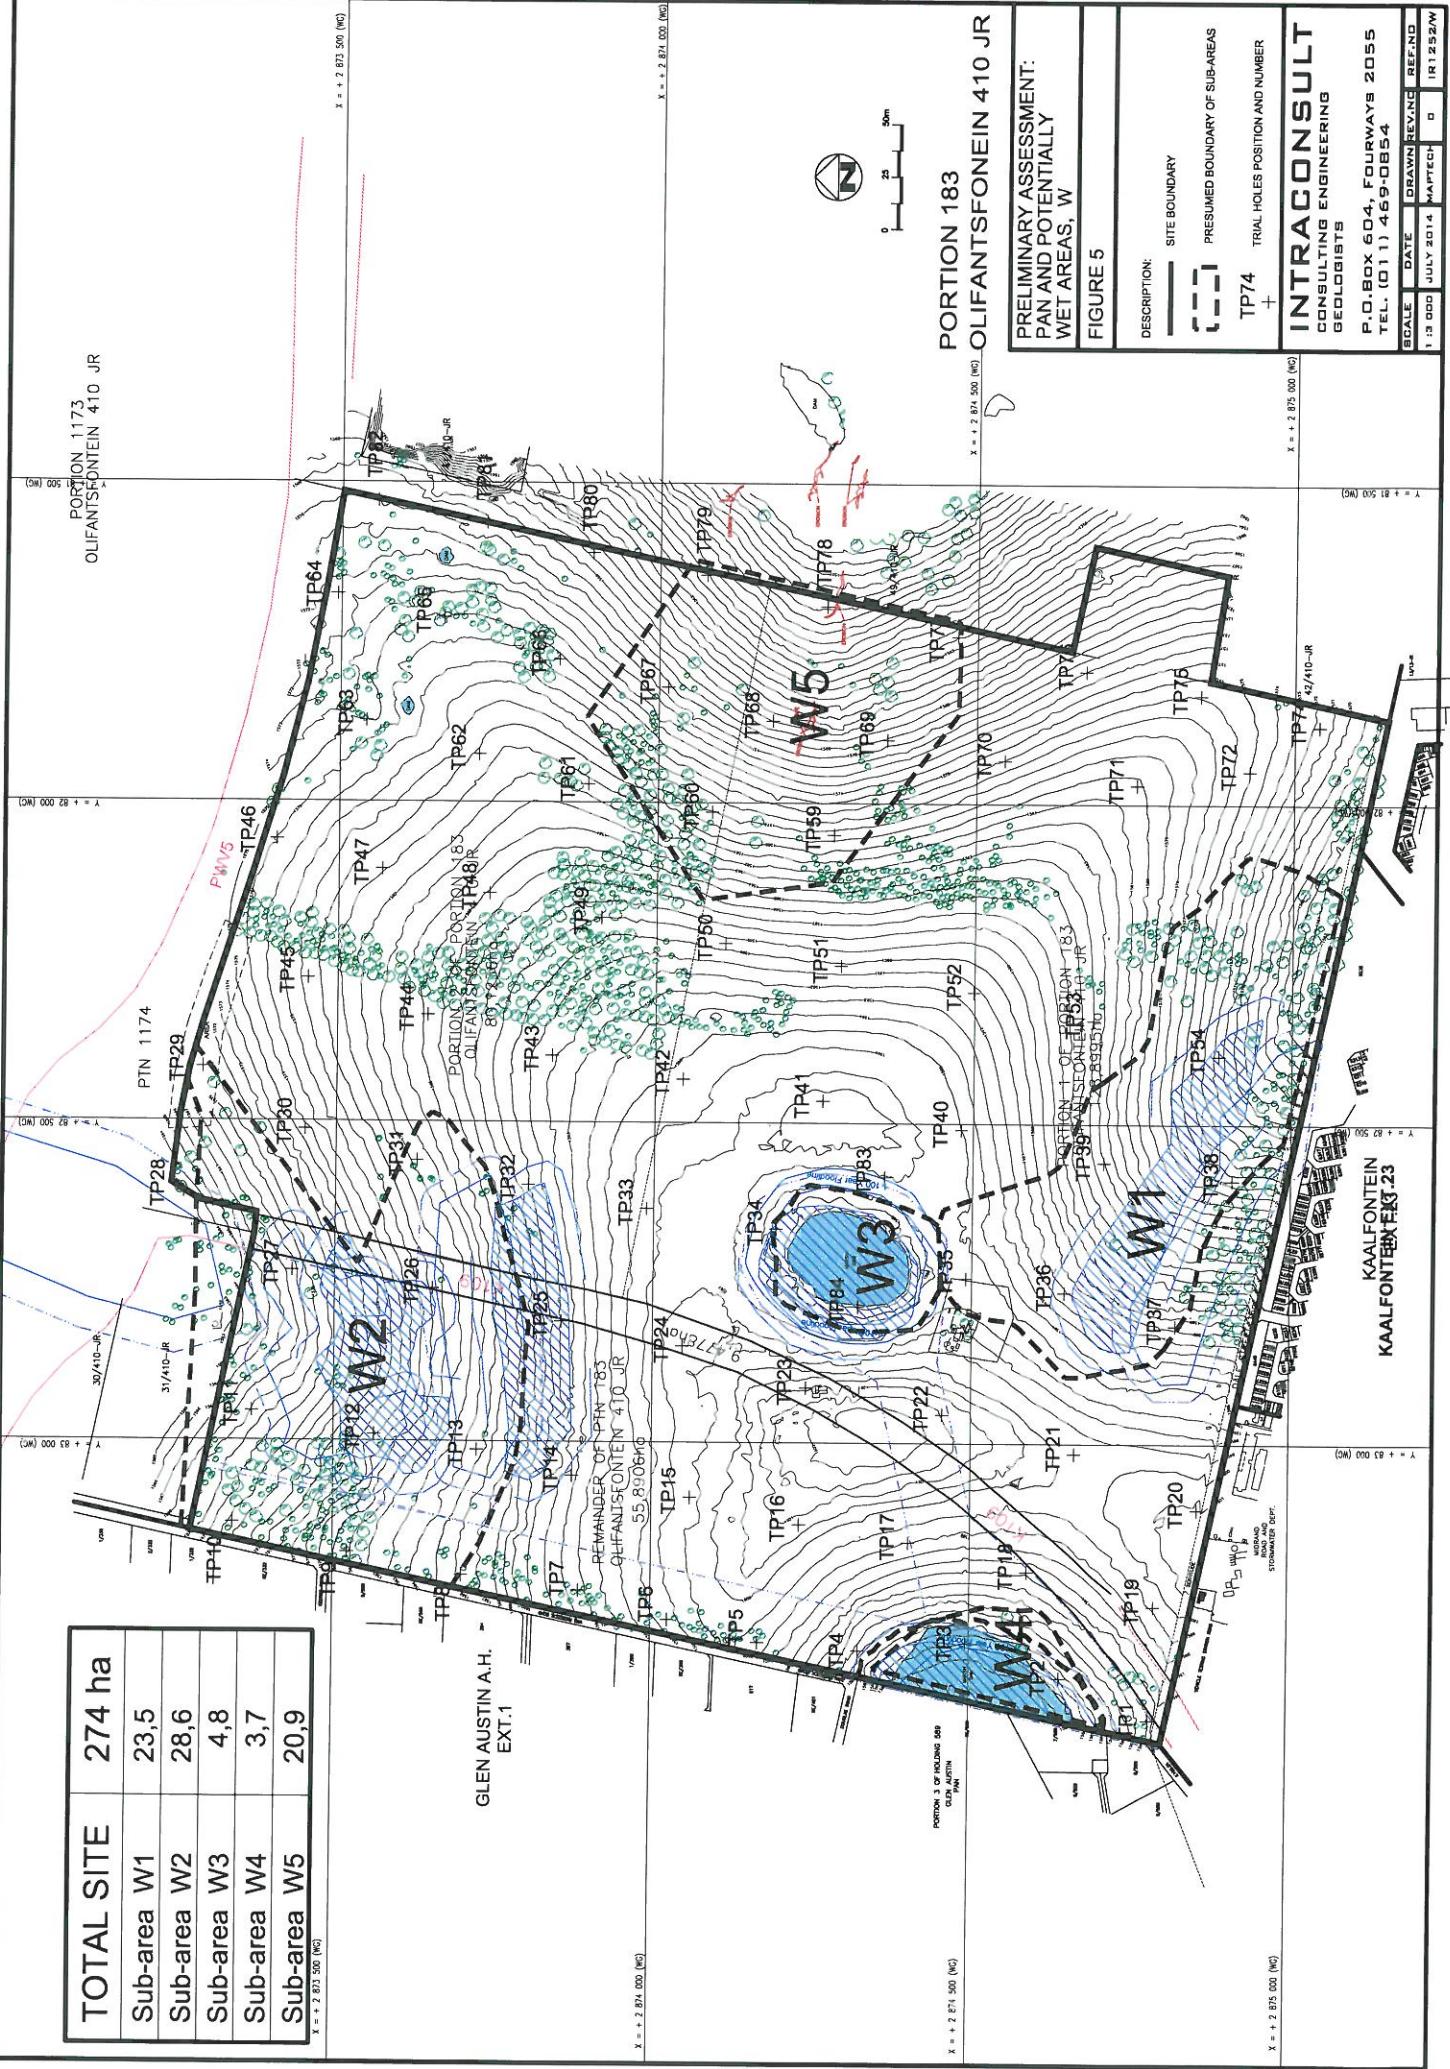
- Figure 5 delineates pans and other sub-areas of the site potentially impacted during rainy seasons. In our experience, stormwaters seep through the (leached-out) surface hillwash soils and run downslope on top of (typically) shallowly underlying pedocretes (see Plates 1 and 4). Such poor natural drainage can result in practically impassable conditions for wheeled vehicles after heavy rains.
- Figure 6 shows the general directions of natural surface drainage across this site.

Signs of potential seepage and perched water tables were noted in many of the opened trial holes and are probably associated with the impermeable nature of the underlying pedocrete soils and bedrock across this site (see Figure 5, sub-areas W1, W2, W3, W4 & W5).

<b>TOTAL SITE</b>	<b>274 ha</b>
Sub-area W1	23,5
Sub-area W2	28,6
Sub-area W3	4,8
Sub-area W4	3,7
Sub-area W5	20,9

These seepage zones (prefixed 2/3W) require particular attention. The following comments and recommendations apply:

Special care will be required for the design (and drainage) of services in close proximity to any of the existing natural drainage paths that occupy sectors of this site, as spring/seepage conditions may be expected to occur in such locations during periods of heavy or continuous rain.

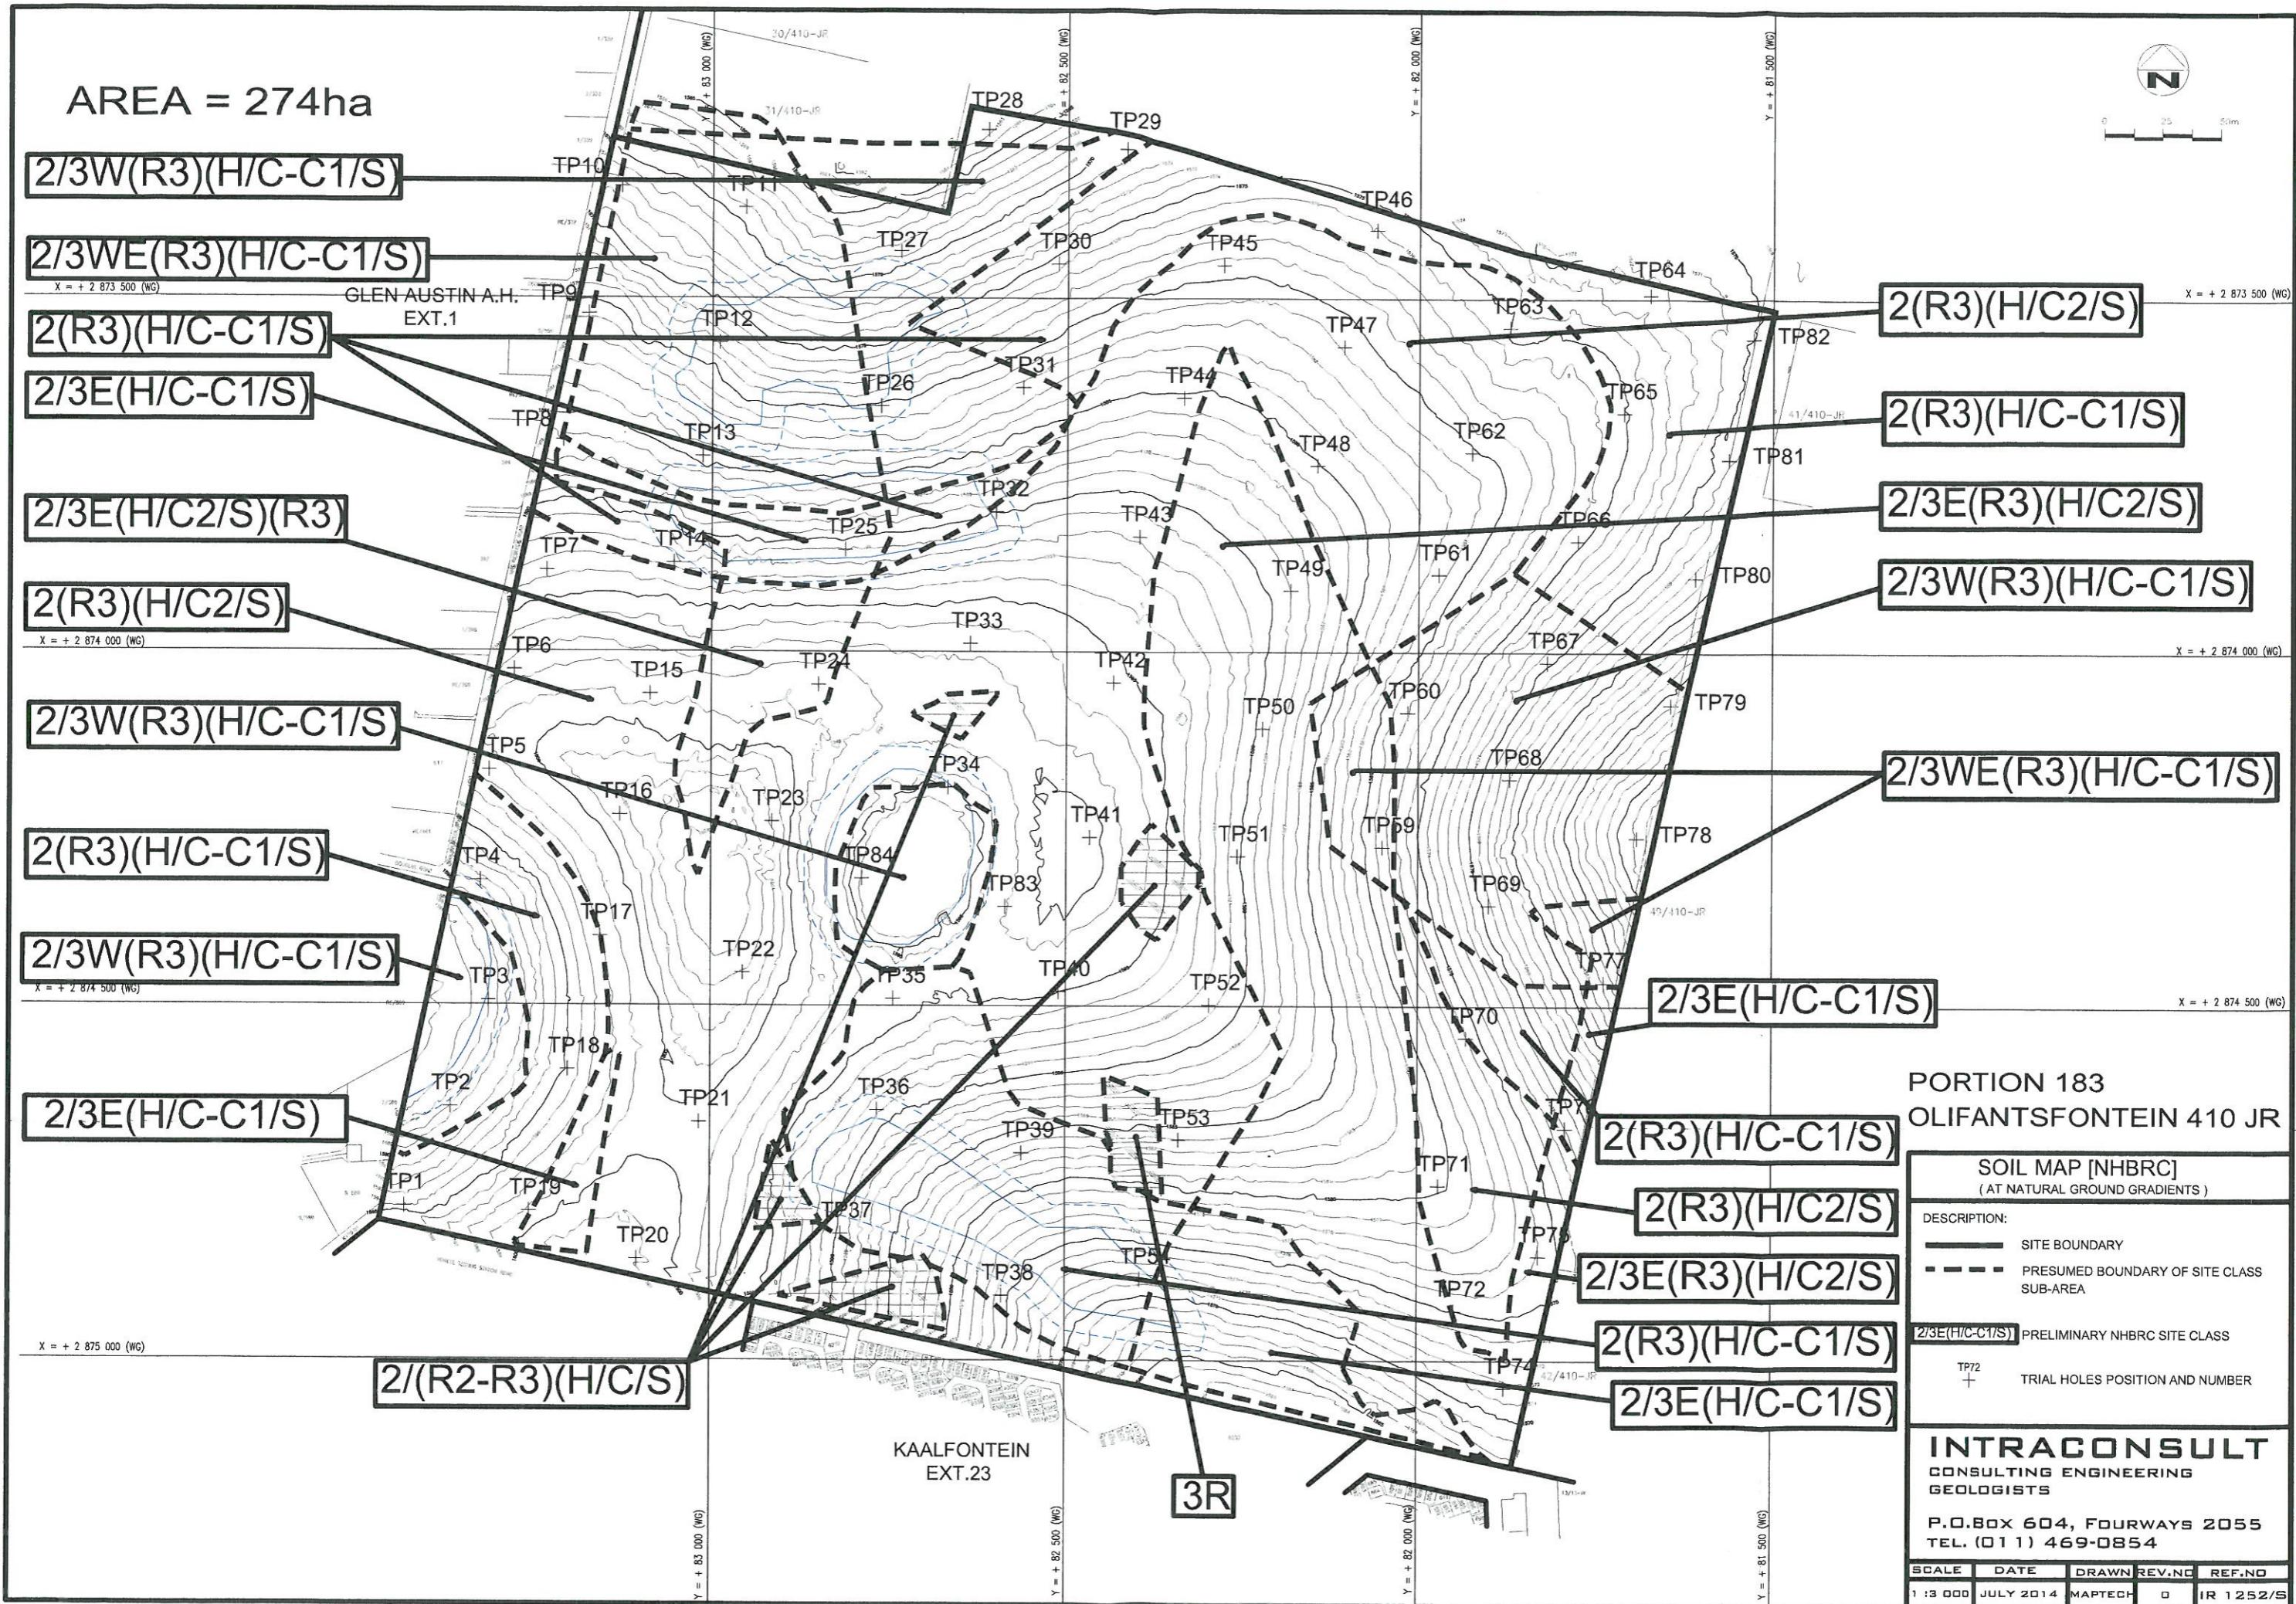
IR1252/S

A Soil Map (Drawings IR1252/S) has been compiled reflecting this total conceptual Site Class Sub-Area characterisation. Our characterisation of the near surface conditions for the Sub-Areas shown on the Soil Map is as follows:-

Sub Area	Commentary
(3R)	<ul style="list-style-type: none"> <li>Solid hard rock granite outcrop – most probably an un-developable sub-area<sup>1</sup>.</li> </ul>
2/3 W (R3) (H/C-C1/S)	<ul style="list-style-type: none"> <li>Seepage sub-areas (requiring special drainage design) masked by solid and organic waste materials. Pockets of difficult excavation conditions in 0.0m to 1.5m profile and below.</li> <li>Potentially collapsible (C-C1) near surface soil conditions.</li> </ul>
2/3 E (H/C-C1/S)	<ul style="list-style-type: none"> <li>Natural soils masked by solid and organic waste.</li> <li>Potentially collapsible (C-C1) near surface soil conditions</li> </ul>
2/3 E (R3) (H/C2/S)	<ul style="list-style-type: none"> <li>Natural soils masked by solid and organic waste.</li> <li>Pockets of difficult excavation conditions in 0.0 to 1.5m profile and below, otherwise –</li> <li>Thick layers of potentially collapsible near surface soils (C2) in these sub-areas of the site.</li> </ul>

2(R3) (H/C2/S)	<ul style="list-style-type: none"> <li>Pockets of difficult excavation conditions in 0.0 to 1.5m profile and below, otherwise-</li> <li>Thick layers of potentially collapsible near surface soils (C2) in these sub-areas of the site.</li> </ul>

2(R3) (H/C-C1/S)	<ul style="list-style-type: none"> <li>Pockets of difficult excavation conditions in 0.0 to 1.5m profile and below, otherwise-</li> <li>Potentially collapsible near surface soils (C-C1) in these sub-areas of the site.</li> </ul>
2(R2-R3) H/C/S	Scattered outcrop and sub-outcrop of medium and hard rock boulder conditions in these sub-areas of the site.

Possible foundation solutions are further complicated by the possible presence of 'hard' and 'soft' materials immediately beneath individual footprints as a consequence of local rock sub outcrop. It is recommended that all soils are precompacted below foundation works.

Recommended alternate foundation design solutions for single storey masonry structures are provided in the NHBRC 'Standards and Guidelines'. However, as many of these even are likely to be developed with double storey structures. It is recommended that engineered rationally designed foundations are adopted on this site.

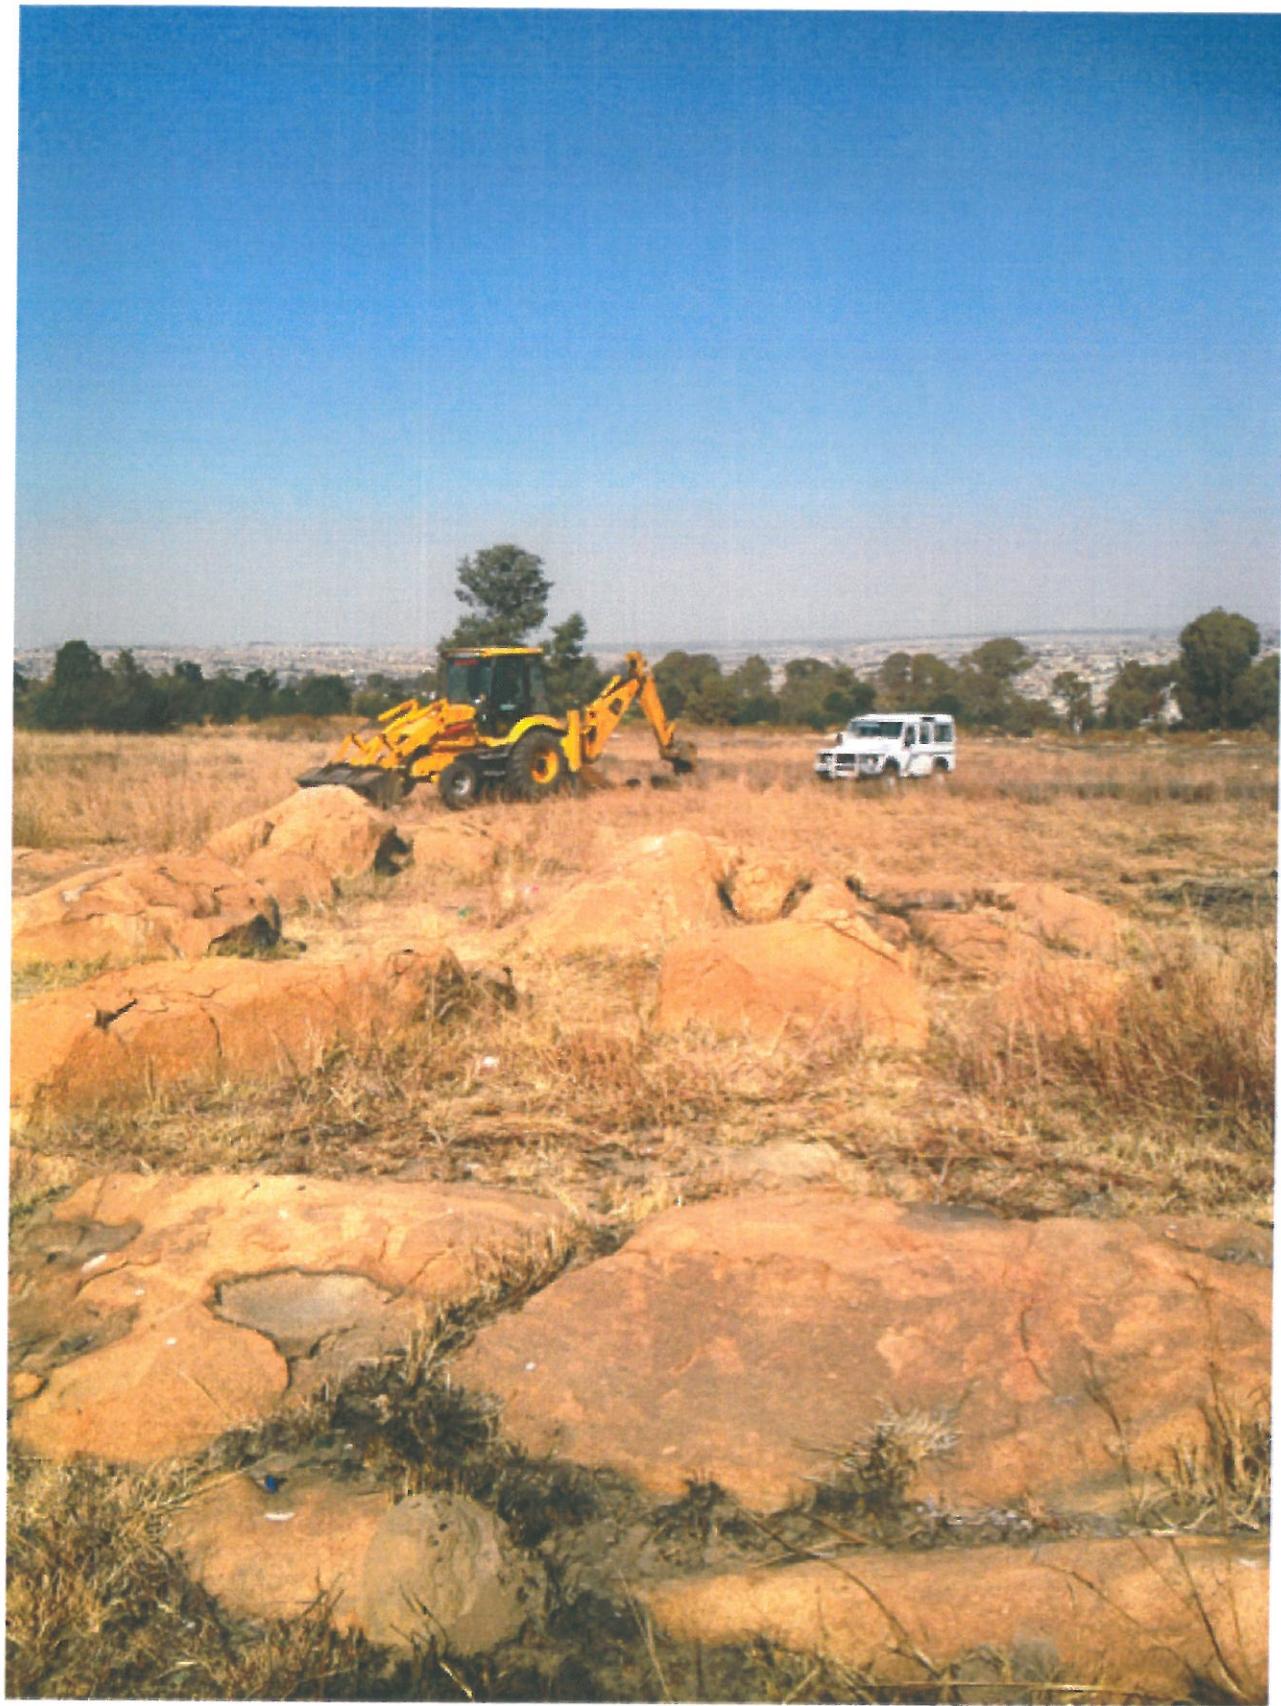
## PLATE 2

TYPICAL GRANITE OUTCROP NEAR TEST PIT 53

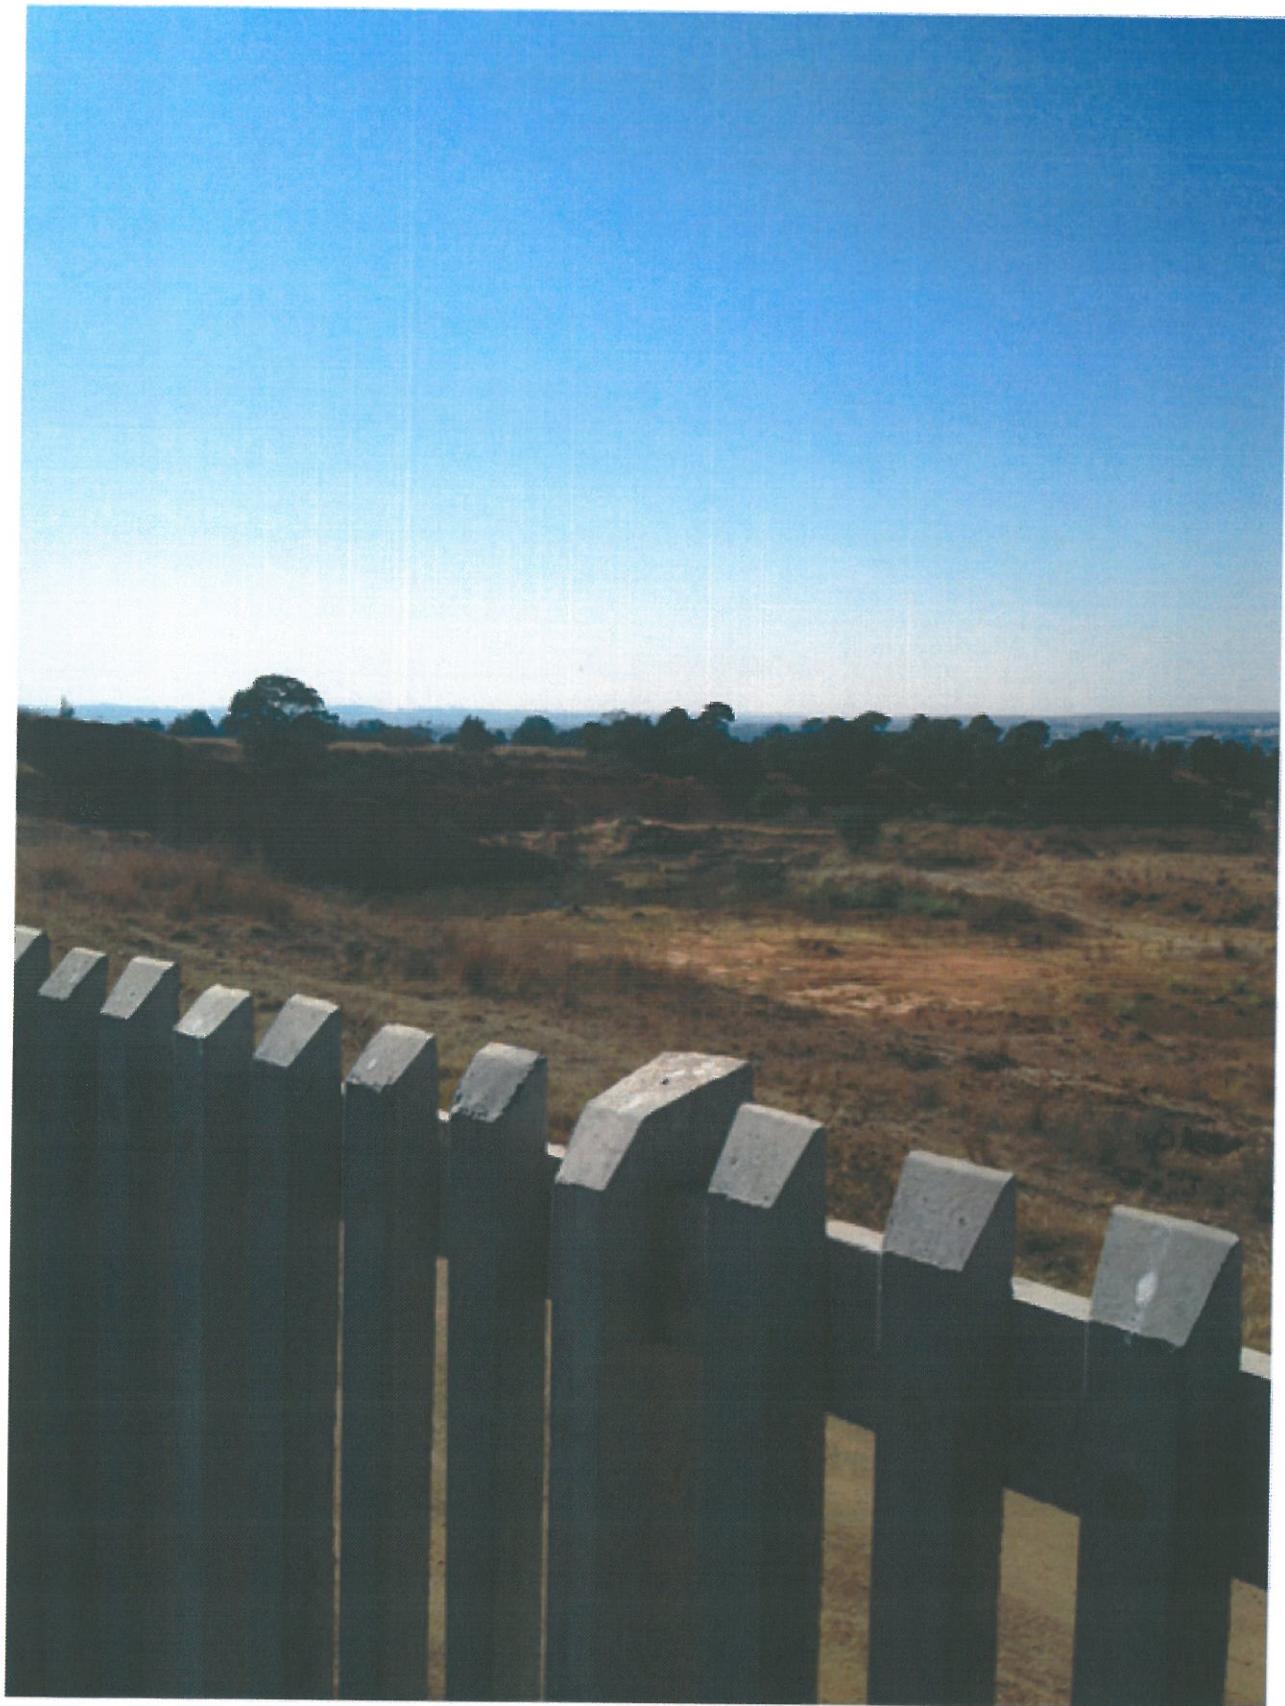
## PLATE 5

LARGE BORROW PIT EXCAVATION ALONG NORTH EAST CORNER
