**WETLAND DELINEATION AND ASSESSMENT FOR A PROPOSED  
DEVELOPMENT NEAR CLAYVILLE, MIDRAND, GAUTENG  
PROVINCE**

**Reference 501/2009**

**PROJECT:** Wetland Delineation and Assessment for a proposed development near Clayville, Midrand, Gauteng Province.

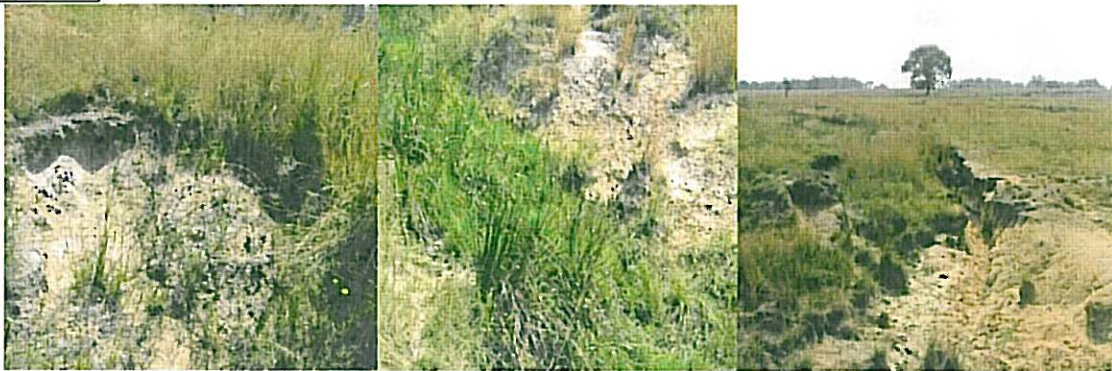
**Figure 4** Sandy soils of the study site derived from weathered granites with exposed hard plinthic horizons in some areas

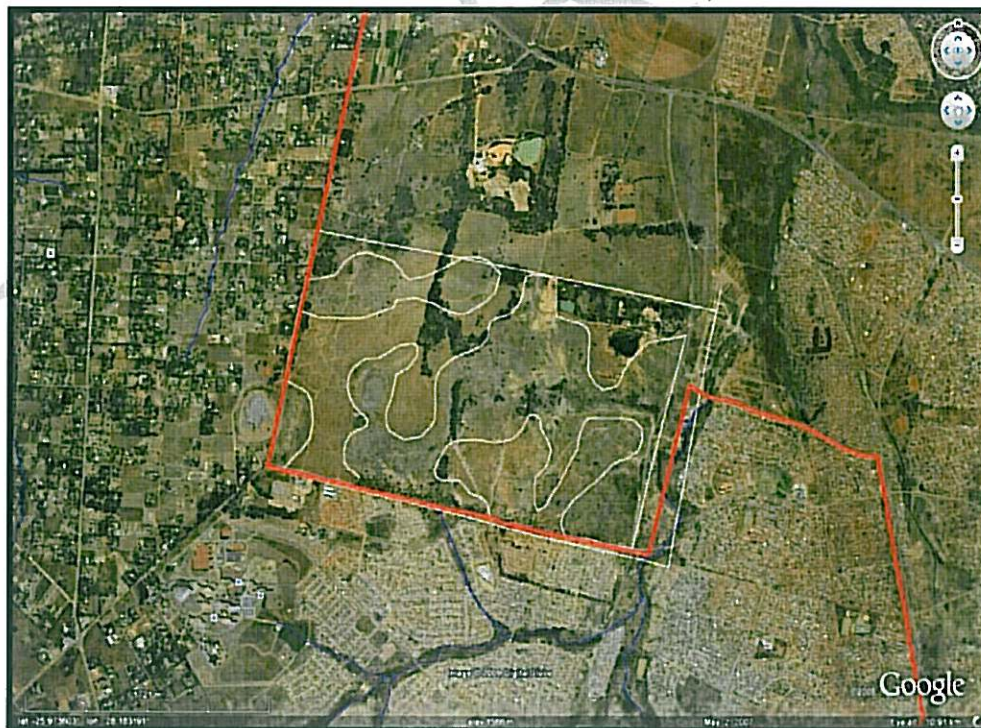
The results of the desktop delineation are illustrated in Figure 7.

**Figure 7:** A map that shows possible wetland areas on site based on desktop delineation (Thompson et al 2002)

Based on the impacts and landuse practices as mentioned, an investigation on site indicates that most of the areas mapped in the desktop delineation exercise above probably were wetlands, but the lack of either an orthic and/or A horizon precludes their classification as wetlands.

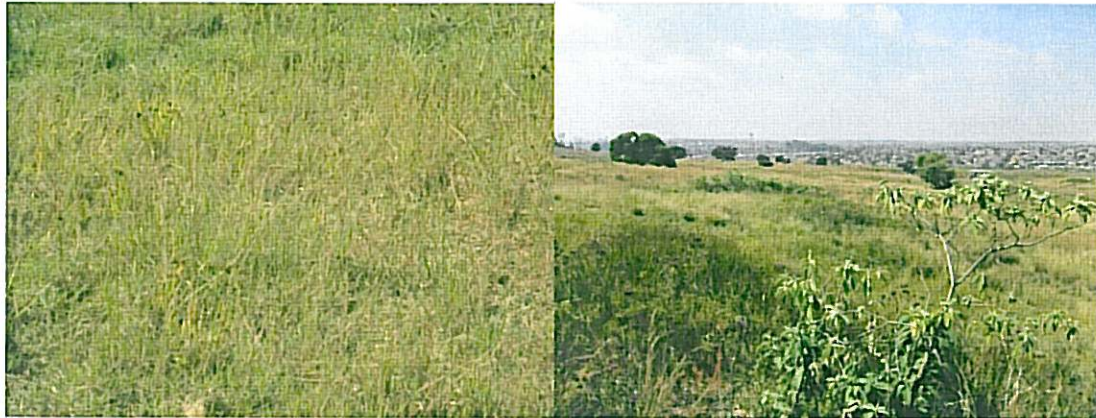
**Figure 10.** Photographs showing typical hillslope seepage wetlands on the site.

The hillslope seepage wetlands occupy approximately 17% (6ha) of the wetland areas recorded on site, equivalent to 360ha (Figure 9). Hillslope seepage wetlands in this environment are associated with the soils derived from and the weathering profile of the Halfway House Granites, the geological formation on which the site is located (Figure 4). In this environment hill slope seepage wetlands are predominantly seasonal associated with summer rains. Rainfall intercepted by the soils, and which enters the soil profile is intercepted by either a soft or hard layer, referred to as plinthic horizons that act as aquitards. These restrict the vertical movement of water in the soils where because of the generally shallow slopes together with the nature of the soils the water remains within the soil profile for long enough to influence both the soil and the vegetation, typically creating wetland conditions. This intercepted water may express itself where the aquitard approaches the surface or in the valley bottoms where it contributes to stream flow. The hillslope seepage wetlands on site consist of deep sandy soils with mottling and gleying depending on the wetness of the soil and shallow soils underlined by hard plinthic horizon (Figure 11).

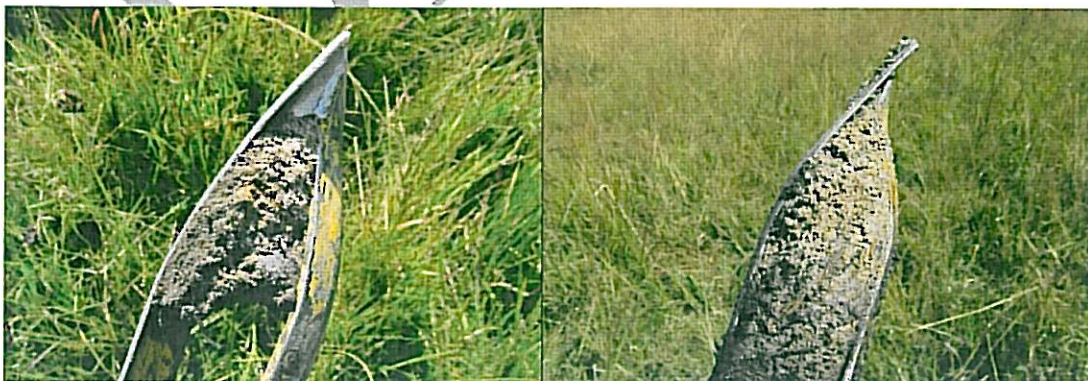
**Figure 11** Photographs showing mottling and gleying observed in some of the soil samples within the hillslope seepage wetland area on site.

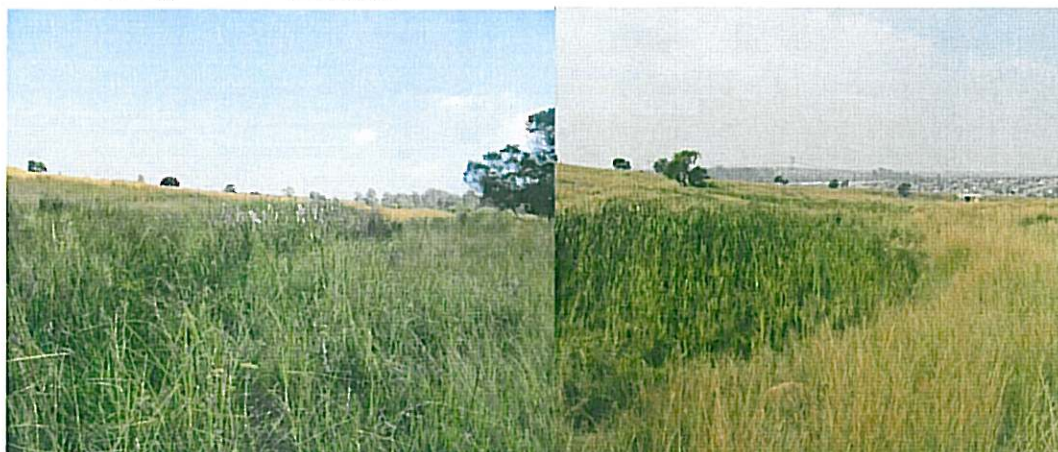
**Figure 12.** Photographs showing characteristics of the valley bottom wetland.

The valley bottom wetland occupies approximately 60% (21ha) of the wetland areas recorded on site, equivalent to 360ha (Figure 9). Unlike the hillslope seepage recorded on site valley bottom systems are characterized by clayey soil, gleyed and dense mottling (Figure 13) in some areas which indicated seasonal variation of water table within this environment.

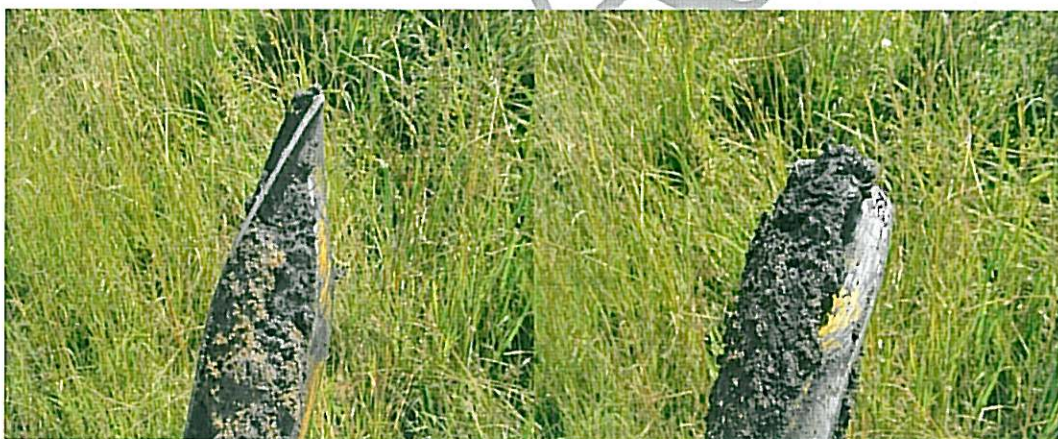
**Figure 13** Photographs showing mottling and gleying observed in some of the soil samples within the valley bottom wetland area on site.

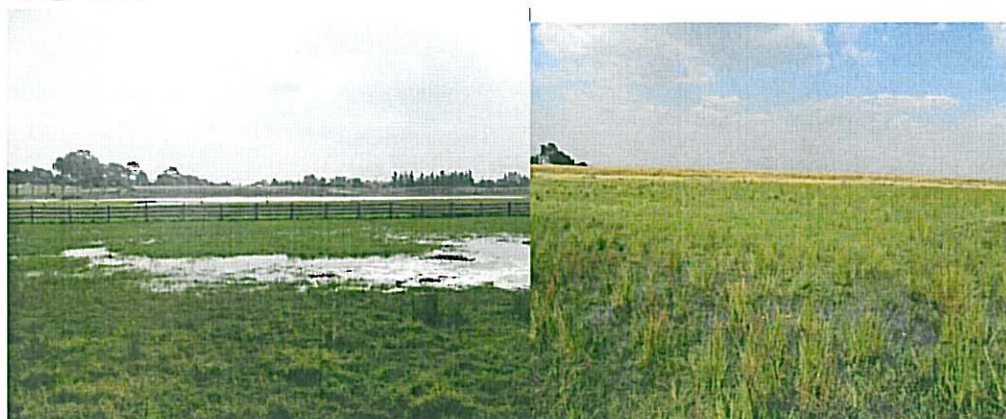
**Figure 14.** Views of the larger of the two pans on the site

Two pans were recorded on site and they occupy collectively approximately 60% (21ha) of the wetland areas recorded on site, equivalent to 360ha (Figure 9) with a portion of Glen Austin pan falls within the study area. The pans were characterized by shallow sandy soil in some places underlined by plinthic horizon. The edges of the pan are disturbed including dumping and erosion and they are dominated by *Stoebe vulgaris*. Figure 15 below indicate some of the soil samples augured around the pan and as well as disturbances around the edges.

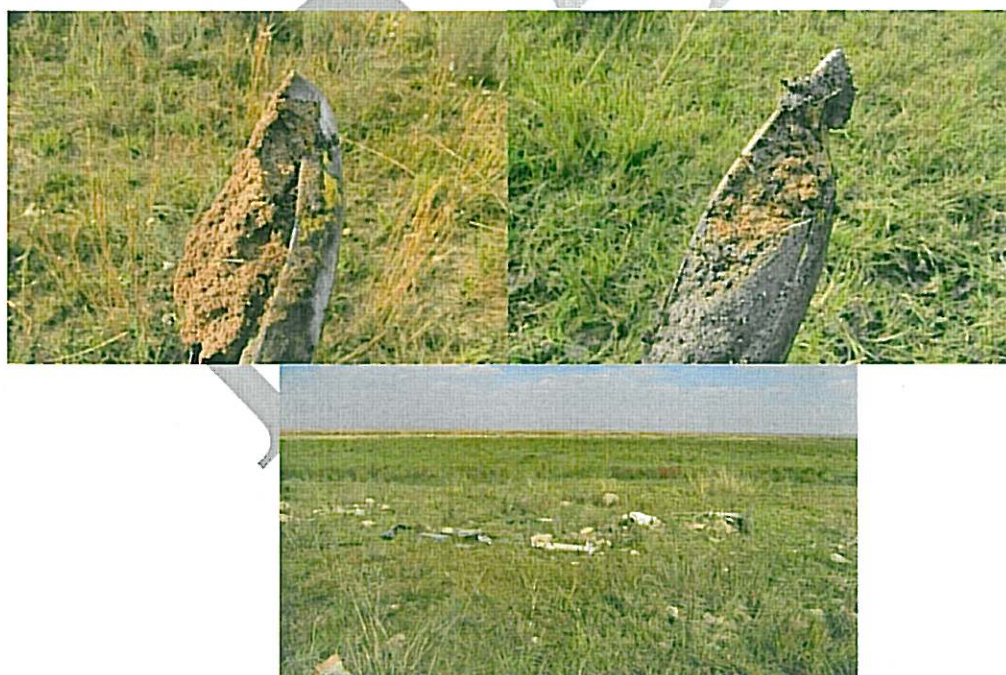
**Figure 15** Photographs showing mottling and gleying observed in some of the soil samples within the pan areas on site.

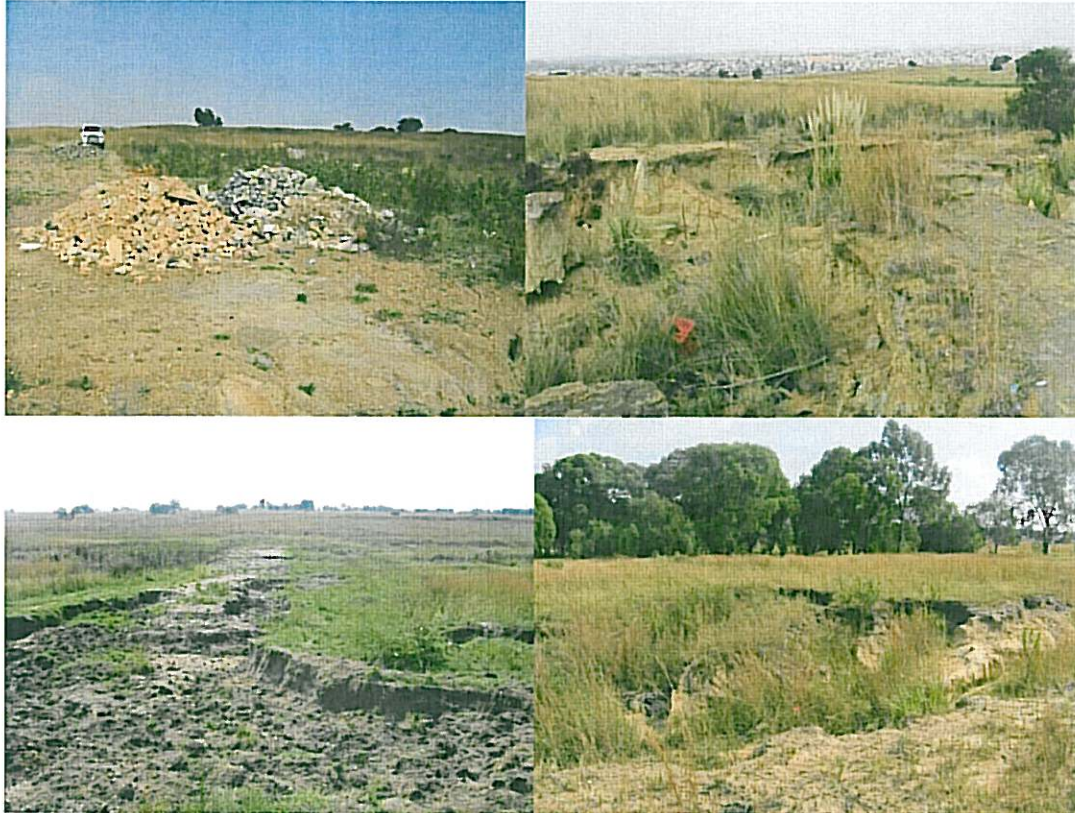
All of the wetlands within and around the study area have been impacted upon to some degree. No pristine wetlands were found to occur within the study area. Evidence was observed on site of transformation of the floristic characteristics of the site. Impacting activities which may have altered the expected floristic composition include grazing, sand burrowing (excavations), impoundments,

road crossings, littering and dumping (building rubble). Some of these activities, and in particular sand mining, has resulted in excessive erosion including active head cutting and gully formation, while littering and dumping and disturbance has encourage the encroachment of alien invasive vegetation. Some of the severe impacts are indicated in Figure 17 below.

**Figure 17** Photographs showing some of the impacts observed on site.
