## **GEOTECHNICAL INVESTIGATION REPORT OF HOLDING 225, GLEN AUSTIN AGRICULTURAL HOLDINGS MIDRAND**

**Prepared for: ROB FOWLER AND ASSOCIATES**

**Report No.: 9406**

**Date: OCTOBER 2006**

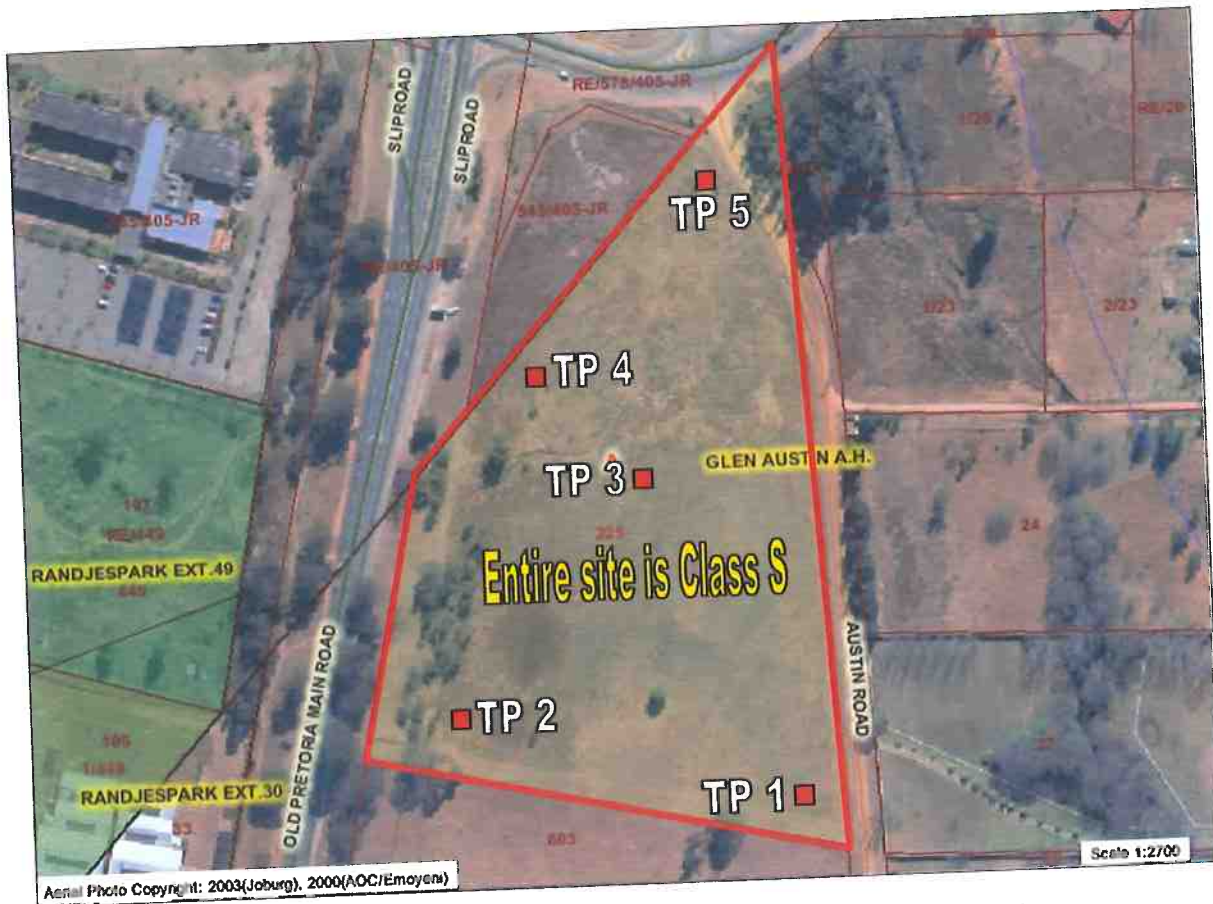
Figure: 2

**Note**, boundaries have been interpolated between trial holes and must be confirmed on site.

**Site Class S** Less than 10mm consolidation settlement anticipated

Approximate Test Pit Position

**SITE PLAN**

On 31<sup>st</sup> August 2006, five test pits were excavated by hand at positions determined on the site. The layout of the test pits are shown on the site plan in Appendix 1. Each hole was profiled by an engineering geologist according to the Jennings, Brink and Williams system, sampled as necessary and backfilled. The detailed soil profiles are presented in appendix 2 of this report.

**S** Less than 10mm consolidation settlement anticipated.

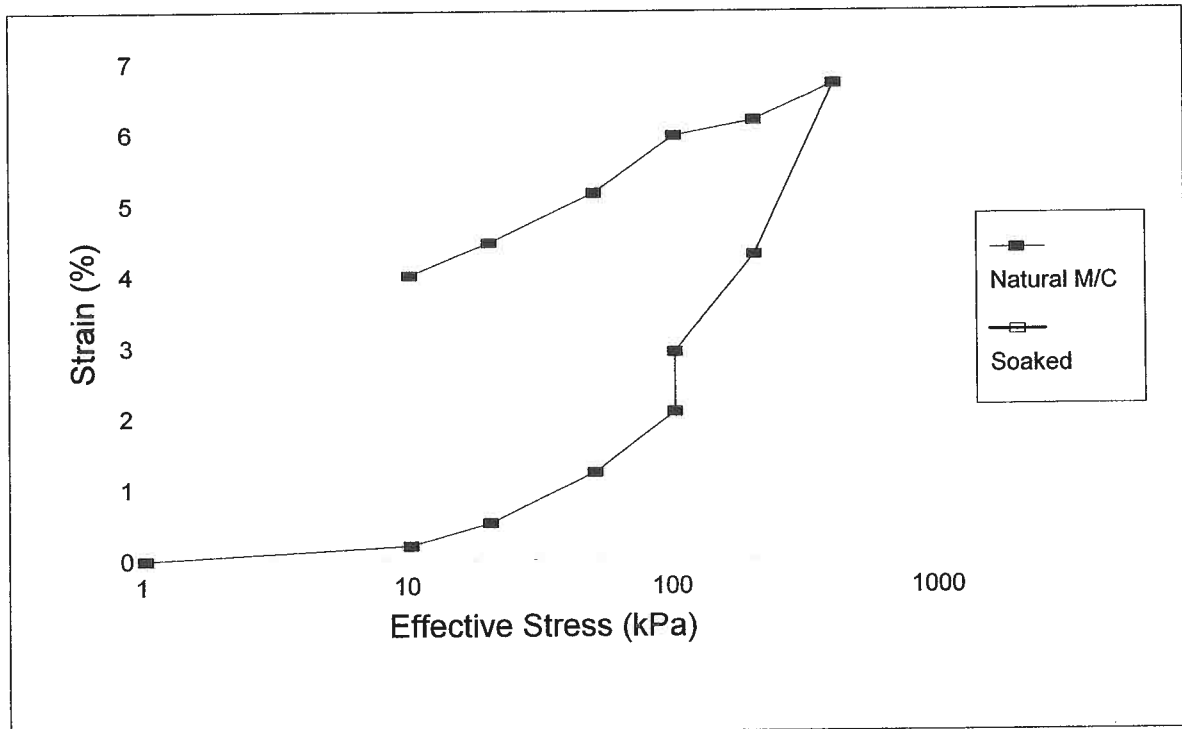
Test No: TP 4 @ 1.2-1.3m

Effective Stress (kPa)	Consolidation Reading	Voids Ratio	Strain (%)
1	10000	0.525	0.000
10	9962	0.522	0.200
20	9900	0.517	0.520
50	9766	0.506	1.230
100	9604	0.493	2.080
100	9462	0.482	2.930
200	9200	0.461	4.300
400	8706	0.421	6.700
200	8822	0.431	6.180
100	8920	0.439	5.970
50	9016	0.446	5.170
20	9148	0.457	4.470
10	9236	0.464	4.010

## STRAIN v EFFECTIVE STRESS

The results are summarised in table 2 below, and show that the residual granite is not potentially collapsable, with the degree of severity of less than 1%. According to Jennings and Knight (1975), this represents "No trouble".

TABLE 2. Collapse Potential Test					
TP No	Depth	Material	Dry Density (kg/m <sup>3</sup> )	Moisture Content %	Collapse Potential %
5	0.7-0.8	Silty sand and gravel with ferricrete. Ferruginised Res Granite	1752	9.23	<1
